Manhole Inspection Summary

Manhole # S41G__004MH

Insp Date: **7/25/08 8:31 AM**

Location Address: **1313 e pratt st**

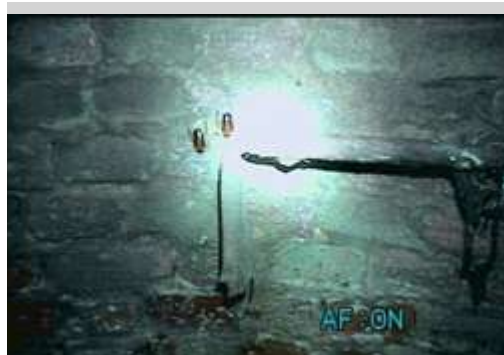
Defect 6

bench debris

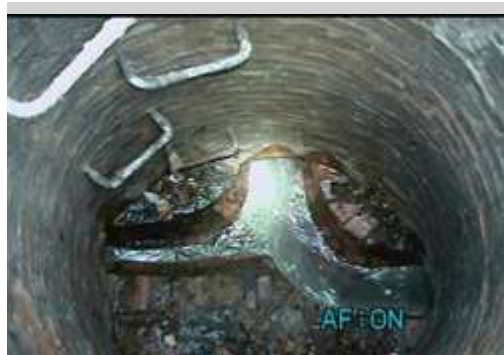
Defect 3

barrel wall infiltration

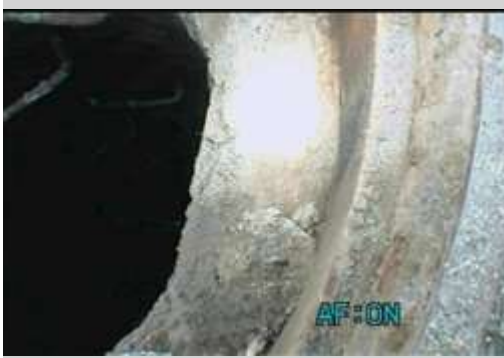
Defect 2

corroded steps

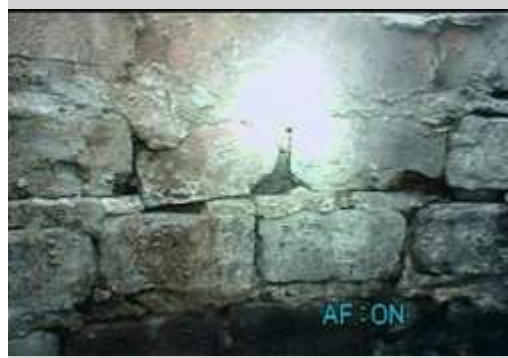
Defect 1

offset

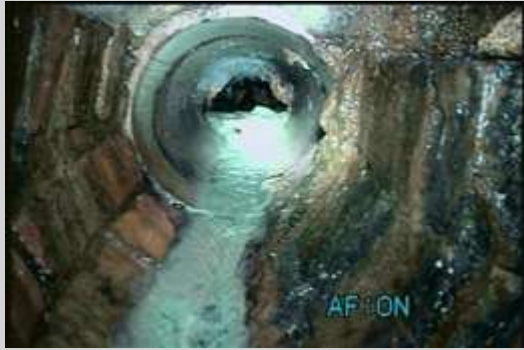
9 O'Clock Inflow

Deposits: ☐ None ☐ Mud ☐ Sludge ☒ **Debris** ☐ Grease

Silt Depth: 0 (in.) Deposits Extent: **Medium**
